# Safety Performance Report on Victorian Electricity Networks 2013

June 2014

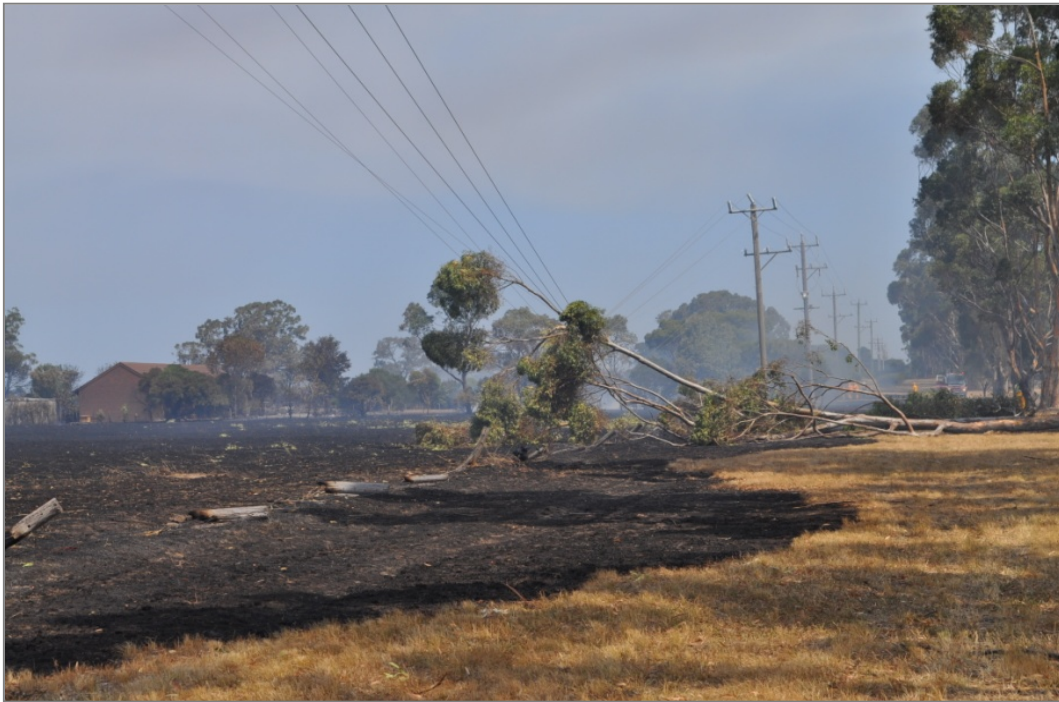
It should be noted that even vegetation located well outside the vegetation clearance space can cause a fire.

Photo 1: Hazard tree located outside of the easement fell into 66kV electric line and started a fire.

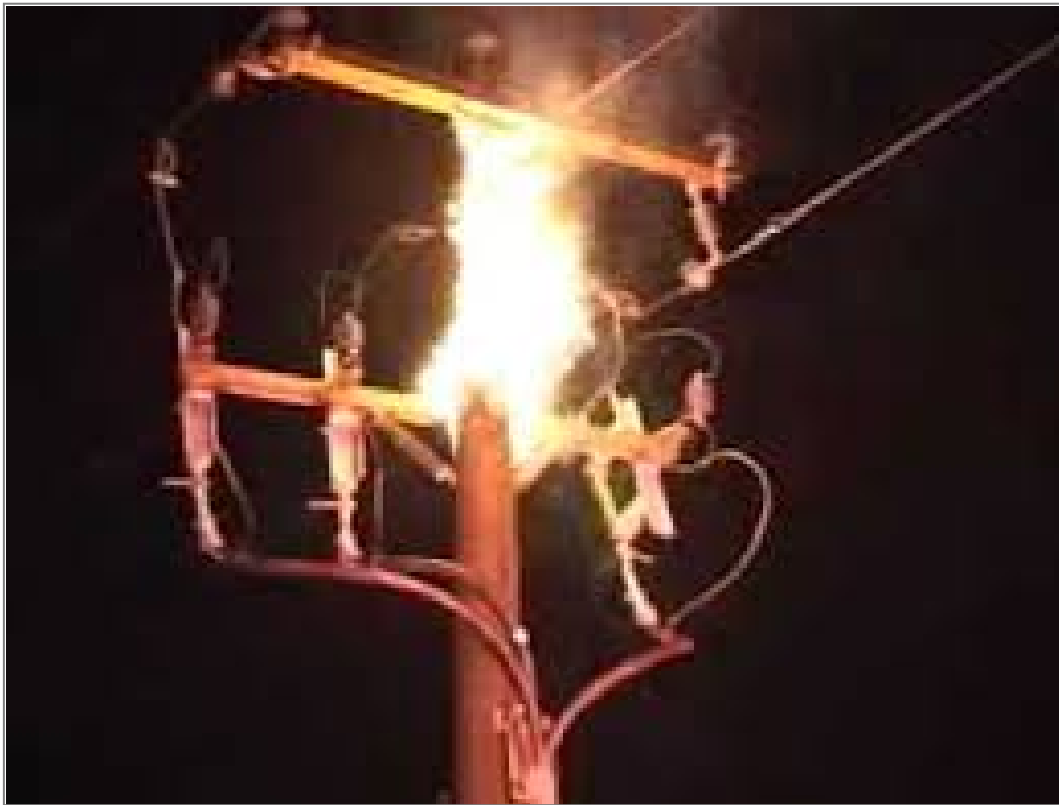
The largest number of asset failures occurred in Powercor region (40 per cent) and the largest number of fires caused by asset failures occurred in Powercor region (54 per cent). Powercor's network may be more exposed to pole top fires than the other distribution MECs due to the proximity of assets to the coast, environmental conditions, and weather conditions.

Photo 2: Pole top fire
