Asset Failure Cause Assessment

22kV Pole Failure

What?	Where?	When?
Staked Wood Pole	MURRAYVILLE WEST 8 - Murrayville	01.01.2020 14:12 Hrs

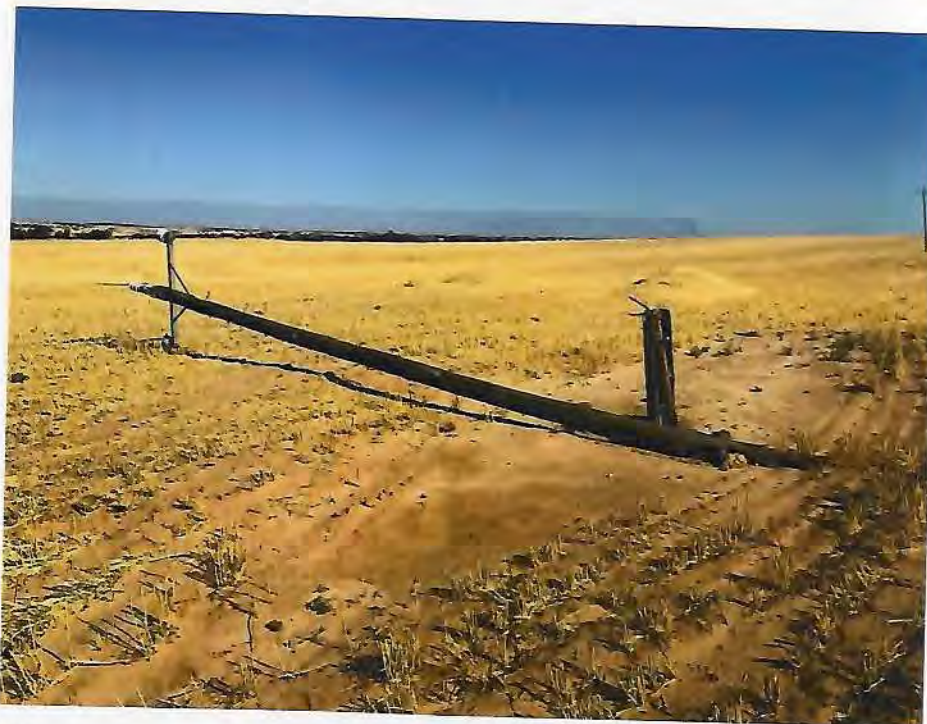
A customer call reported a 'Wire Down' and a pole (MURRAYVILLE WEST 8) had snapped at base. Attending crew recorded that the pole had failed due to internal decay. The crew also noted that a storm had been present at the time of failure.

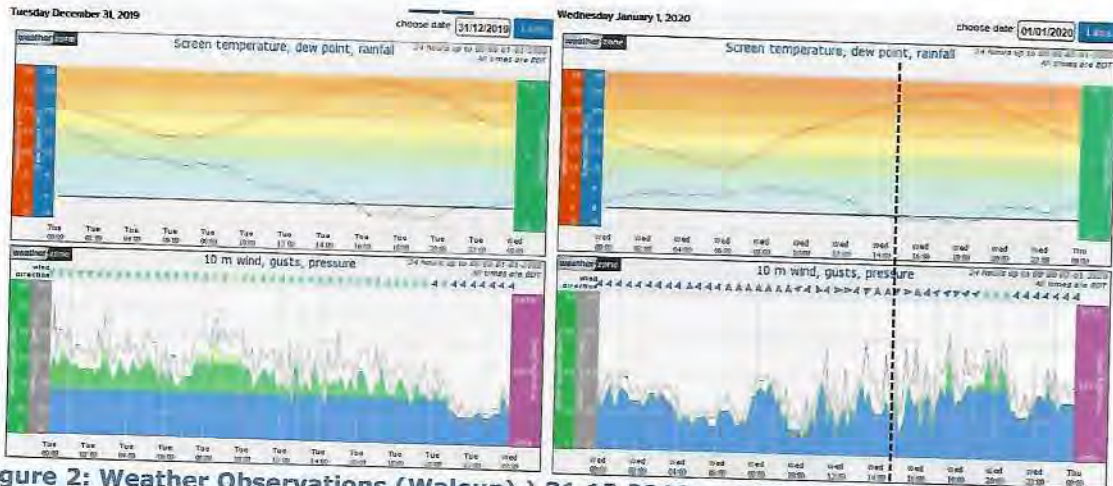
Figure 2: Weather Observations (Waleup)) 31.12.2019 and 01.01.2020. Data measured 77 kms (ENE) DD from the location of the asset failure site

The Fresh (30 - 39 km/hr) to Strong (40 - 62 km/hr) winds gusts recorded prior to the failure are a likely contributing factor in the final failure of the pole at MURRAYVILLE WEST 8. Wind Gusts can often be stronger on site, and attending crew recorded that Storm (88 - 117 km/hr) conditions were present at the time of failure.

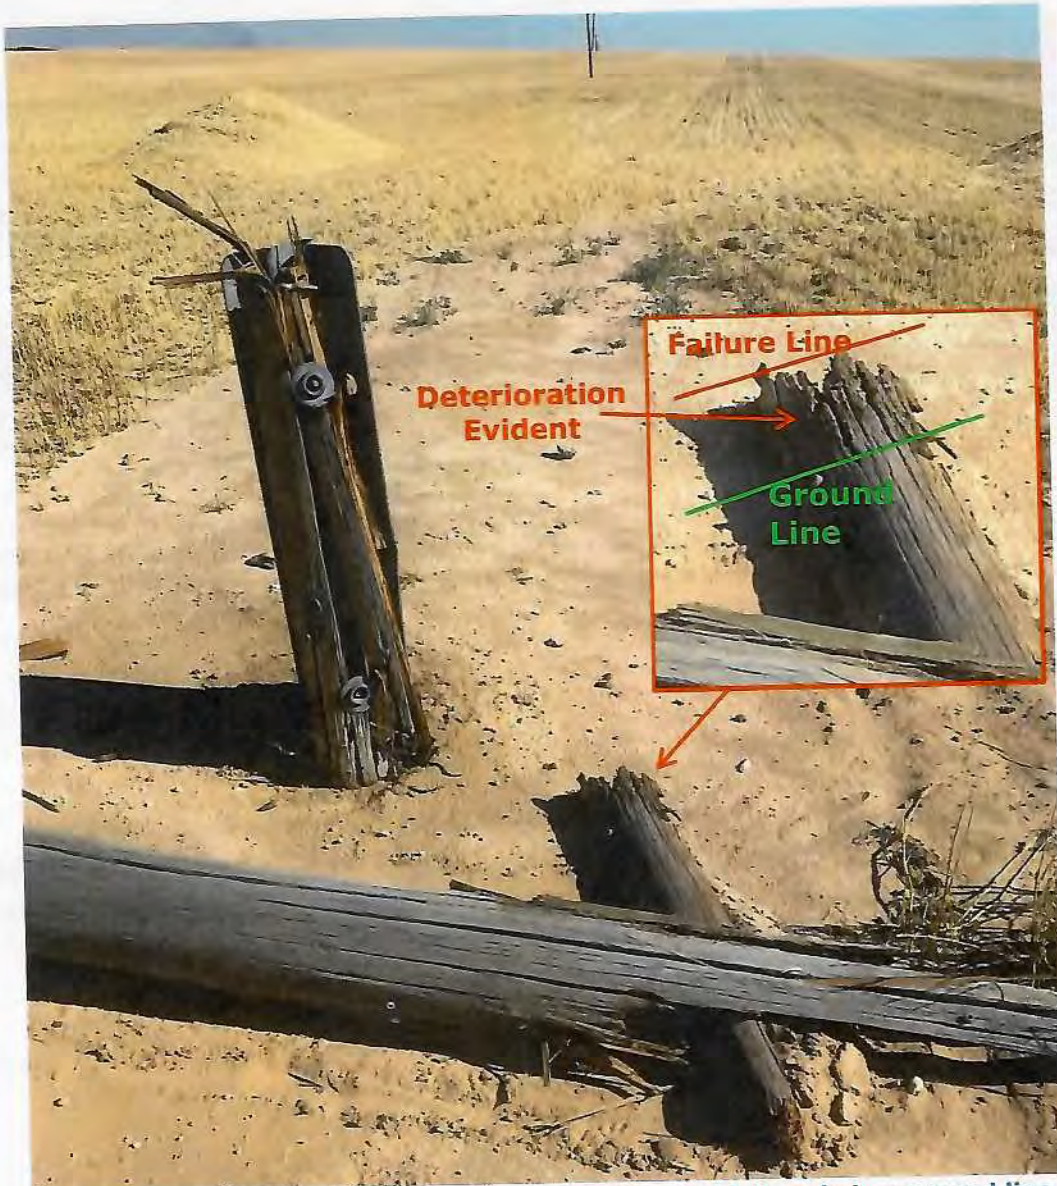
The root cause of failure of the pole below ground line is due to internal and external rot and decay. The presence of a moment force present at the top of the stake due to storm strength wind gusts against the pole above the stake would have contributed to the failure of the pole.

Inspection of the photographs of the failed pole show evident deterioration below ground level, this is where the pole is likely to have initially failed (see Figure 3).

Figure 3: MURRAYVILLE WEST 8 – Deterioration and failure below ground line highlighted

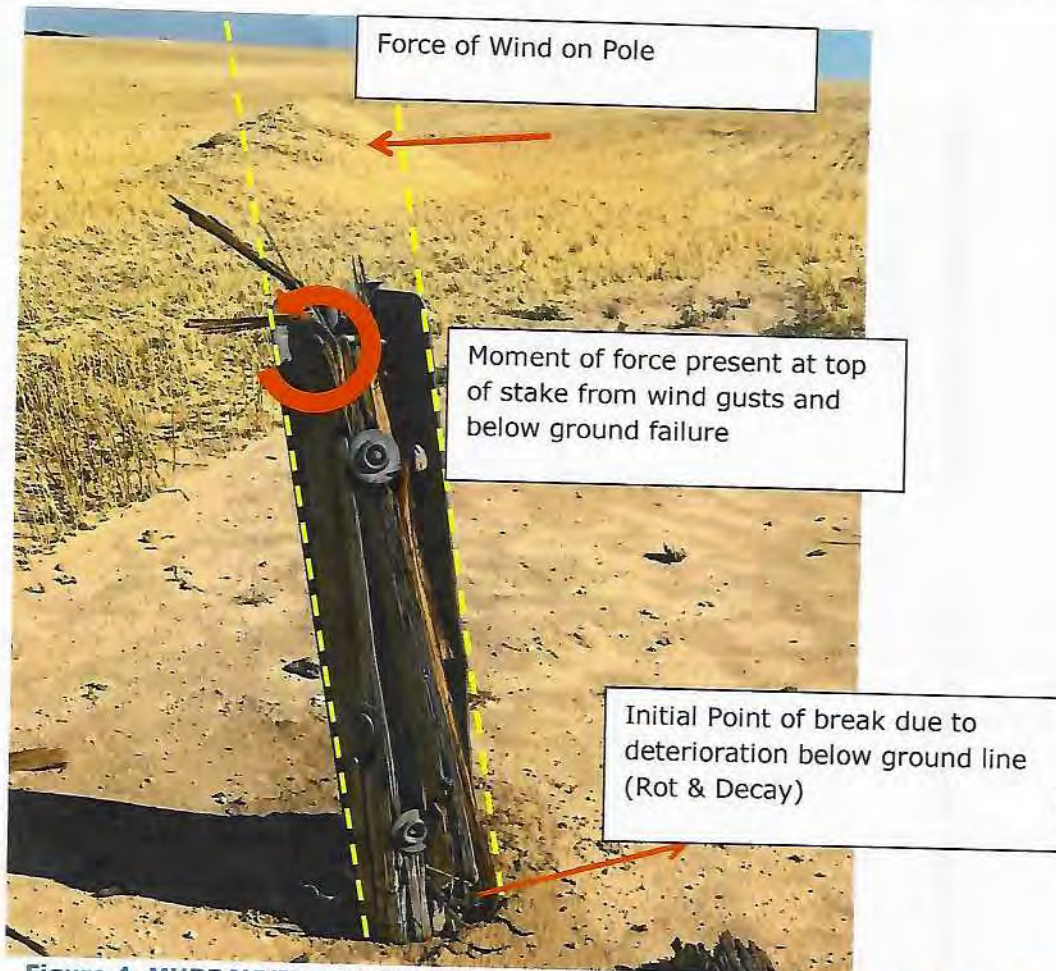
Figure 4 also demonstrates the presence of a moment force present at the top of the stake due to forces applied by storm strength wind gusts against the pole above the stake. These would have contributed to the failure of the pole below ground line where Internal and external rot and decay were previously recorded (Root cause of Failure).

Figure 4: MURRAYVILLE WEST 8 – Forces applied to pole resulting and failure below ground line
