# MMI Exposed LIVE parts

## Multiple Mode Inverters with Back Up Ports

### Safety alert

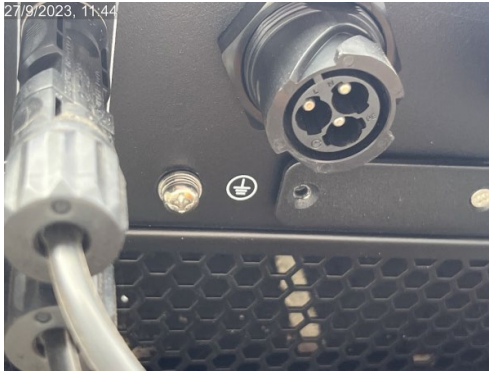
Image 1

On a number of occasions it has been found that the EPS or Back Up port connector has not been fitted to the MMI as per the manufacturers instructions. This Leaves the terminals of the output port exposed, allowing potential direct contact to LIVE parts.

**Image 1** - shows the exposed live terminals of an MMI with the EPS port connector left off by the installer.

LEW's must ensure that all parts, covers and connectors supplied with the product are fitted as per the manufacturers instructions, and that no exposed live parts or parts that may become live under normal operation exist.

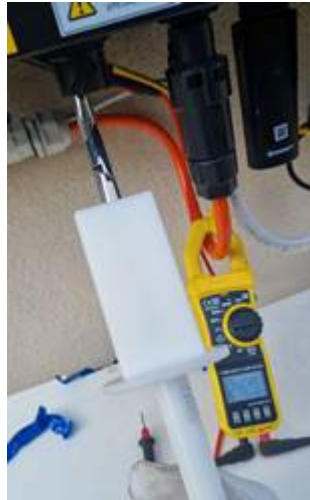
Image 2

In some cases the output port socket is not IP2X and is enabled by default, therefore the exposed LIVE terminals allow a risk of electric shock, FAILING a standard finger test recording 242 V a.c. to earth.

**Image 2** - shows a standard finger test recording a FAIL result with 242 v a.c. tested at the exposed EPS pins with reference to earth.

Electrical Equipment that pose a risk of electric shock should not be installed and shall not be energised.

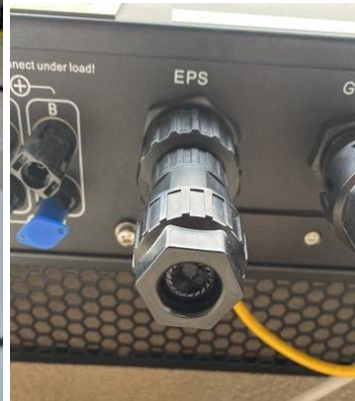
Image 3

**Image 3** shows the supplied EPS connector that must be fitted to prevent contact with the EPS port terminals. *Note: If the connector can be removed without the use of a tool, see below for additional guidance.*

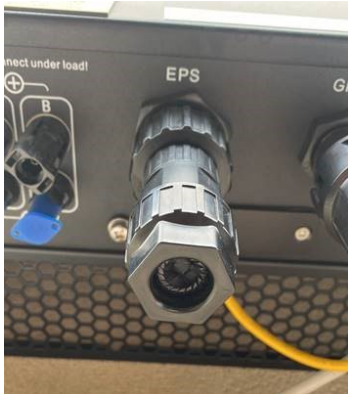
Image 4

Some MMI's have been identified to be supplied with a cable connector type which can be removed without the use of a tool, then allowing access to live parts. This issue has been identified on both the Back Up port connector and the MMI a.c. supply connector.

This is deemed to be non-compliant to AS/NZS 4777.2 Clause 2.3.3.1

**Image 4** - shows the supplied EPS connector that can be removed without the use of a tool, to access live parts.

Products identified to be non-compliant should not be installed and should not be left energised. LEW's are advised to contact the product supplier/manufacturer and obtain a purpose designed locking mechanism for the product to ensure the connector/s cannot be removed without the use of a tool.

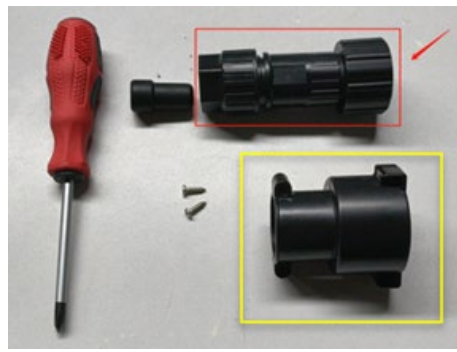
Image 5

**Image 5** - shows the manufacturers EPS connector with a lockable shroud to be fitted.

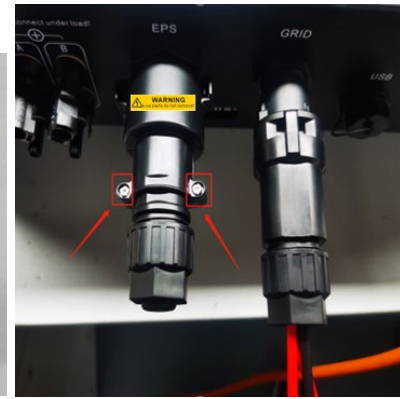
Image 6

**Image 6** shows the supplied EPS connector with the lockable shroud fitted that allows the connector to only be removed with the use of a tool.

Note: The shroud shall be clearly labelled "WARNING Live Parts do not remove!"
