# Safety Performance Report on Victorian Electricity Networks 2013

June 2014

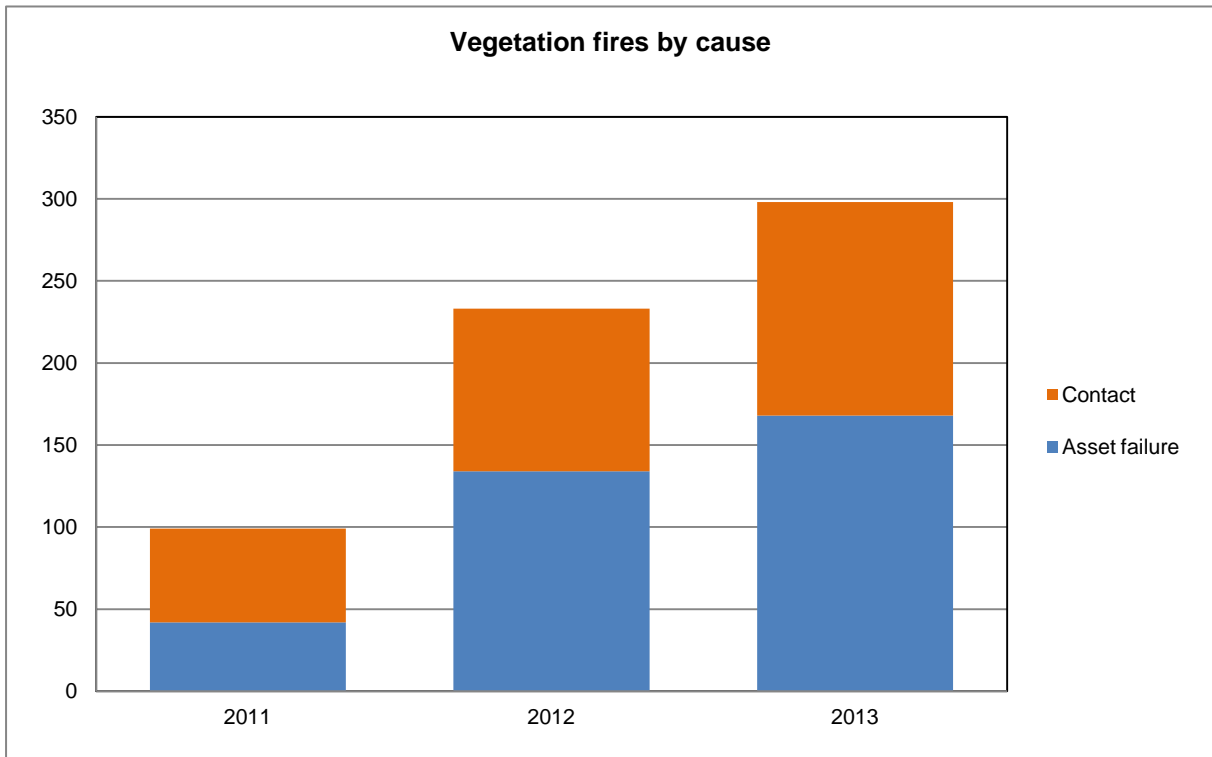
Figure 23: Vegetation fires by cause

CitiPower, Jemena and United Energy all exceeded the number of fire starts approved by the AER for vegetation fires by more than 300 per cent. This increase, while of concern to ESV, is off a low base and generally confined to LBRA.

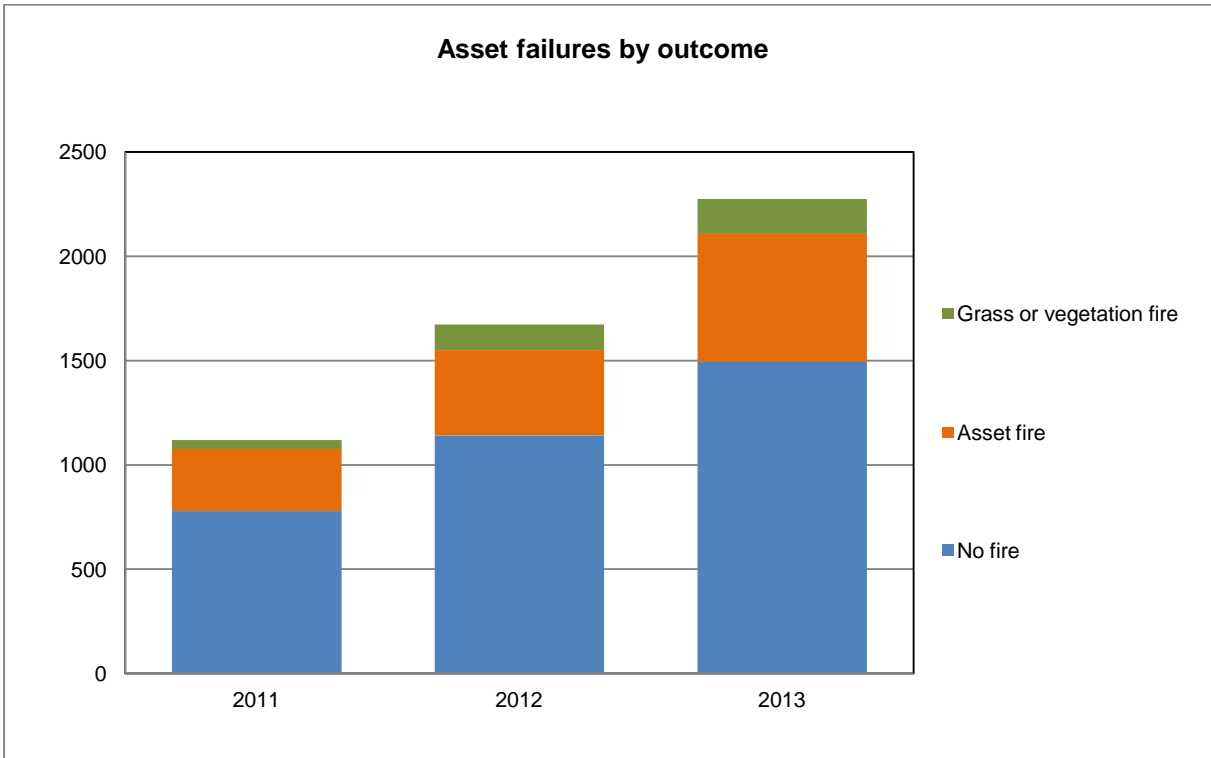
Figure 25: Asset failures by outcome

- the total number of asset failures increased from 1119 to 2269 (103 per cent increase)
- the total number of fires caused by asset failures increased from 341 to 780
- asset failures started more vegetation fires than tree contact; 168 fires compared with 60 respectively.

- 1251 (55 per cent) of all asset failures were due to HV fuses and pole top structures (an increase from 519 in 2011)
- 493 (80 per cent) of the asset fires (no vegetation fire) were due to HV fuses and pole top structures (an increase from 212 in 2011)
- 63 (38 per cent) of the vegetation fires were due to HV fuses and pole top structures (an increase from 20 in 2011).

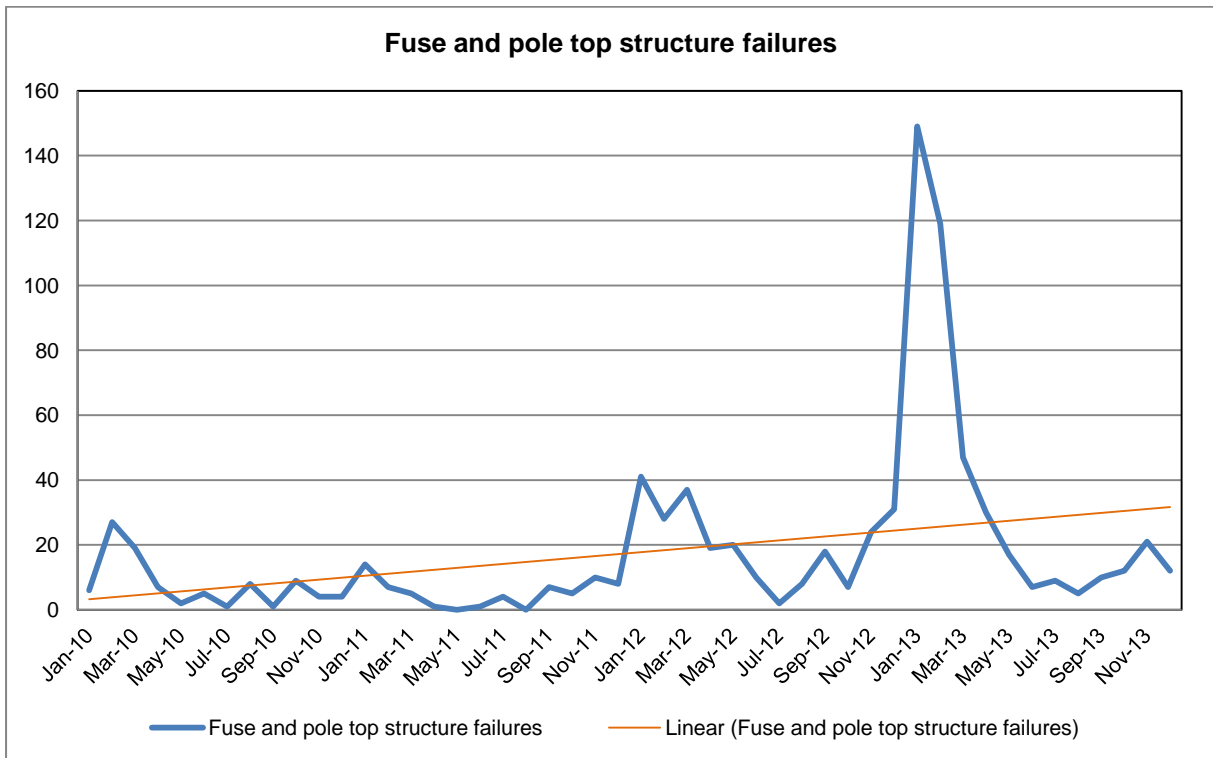
Figure 26: Asset failure: HV fuses and pole tops structures

- 695 of the 932 pole top structure failures (75 per cent) were due to Powercor and United Energy assets
- 377 and 454 pole top structure fires (83 per cent) were due to Powercor and United Energy assets
- 36 of the total 43 pole top structure failures (83 per cent) that resulted in a vegetation fire were due to Powercor assets.

Analysis of asset failures over the past three years indicates that pole top structures (and HV fuse) failures increase during the first quarter each year. ESV has commenced an investigation into the cause for this increase in pole top structure failures and fires during the first quarter each year.

The number of pole top structure failures, in some parts of the network, needs to be reduced if the Victorian distribution network is to be comparable with world best practice. Some parts of the industry need to consider moving from their current approach to pole top asset replacement to a more systematic approach to asset replacement, review their condition assessment techniques, review their pole top design practices and review the risk-based approach for the management of poles top assets.
