Safety performance report on Victorian electricity networks

October 2020

energy**safe**
VICTORIA

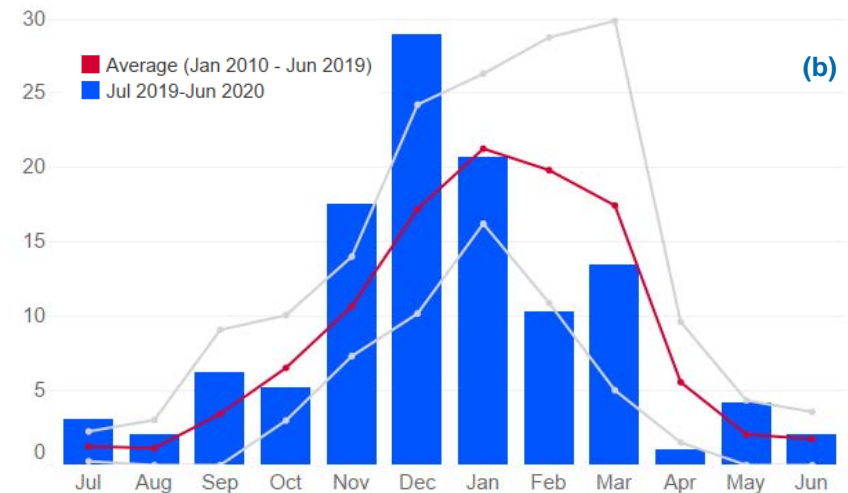
Figure 2 Ground fire incidents due to (a) asset failures and (b) contact events

The averages and bounds in Figure 2 show a clear seasonal trend in ground fires due to both asset failures and contact events. Throughout most of the year, there are similar numbers of fires from asset and contact events; however, there is a more pronounced peak in asset-related ground fires in January and February.

The numbers of asset-related ground fires (red bars in Figure 2a) were within one standard deviation of the 2010-2019 average for most of the year. The exceptions were September and March, which had fewer events, and a higher number of ground fires in December. The peak in December and January reflects the early start to summer that saw extreme bushfire conditions along the entire eastern seaboard of Australia last summer.

Figure 2b shows that the numbers of contact-related fires were well in excess of the historic numbers in July, November and December, with the latter two months also potentially related to the early summer start.

The grey line is one standard deviation above and below the average

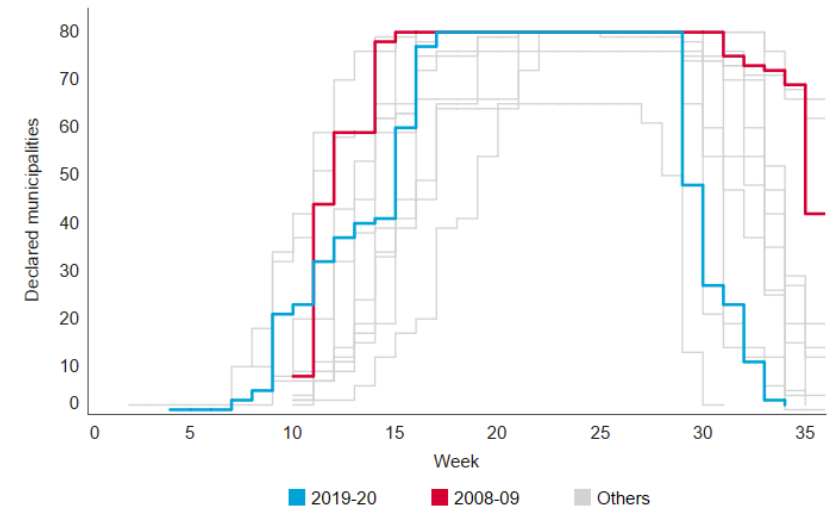
Figure 4 Summary of CFA fire declarations from 2008 to 2020

The first declarations for this year's season started two weeks later than last year, but still weeks earlier than most previous seasons (Figure 4). While the declarations experienced an early jump, the escalation of declarations was much slower than for the Black Saturday fire season (2008-2009). Full declaration was achieved two weeks later than the Black Saturday season, and declarations started coming off and at a faster rate than for the Black Saturday season.

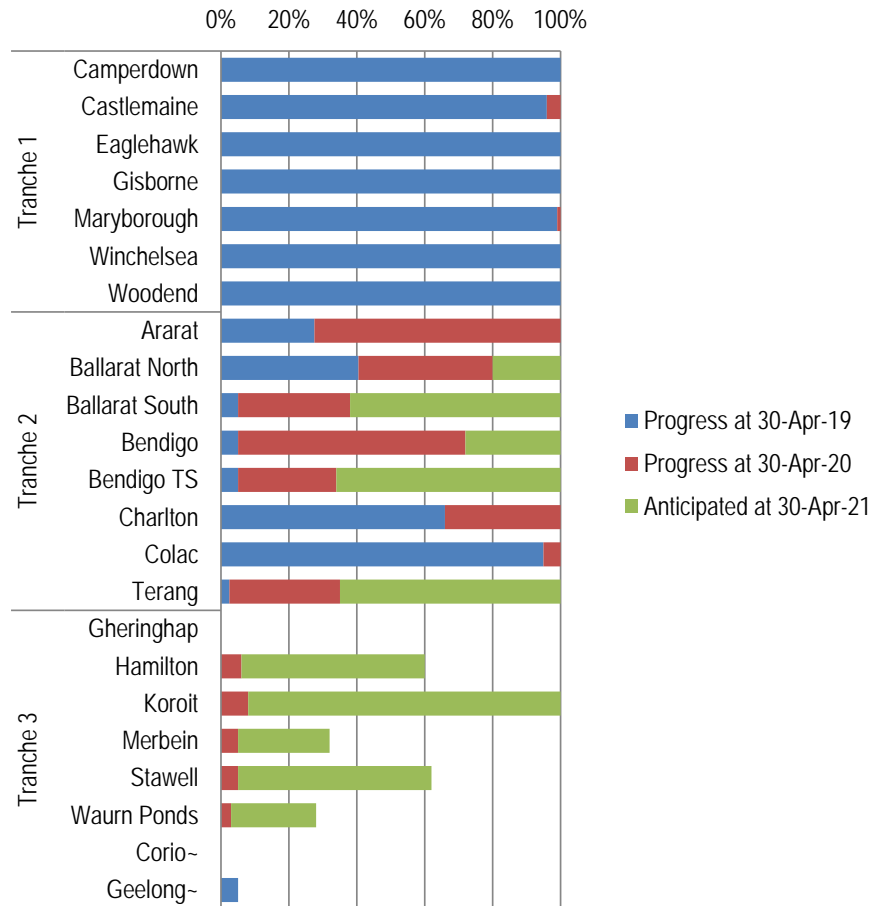
Figure 47 Status of the Powercor REFCL program

~ denotes where an exemption request has been granted

Figure 47 shows the progress of the Powercor REFCL installation program at 30 April 2020 and its anticipated progress in the next twelve months.
