Safety performance report on Victorian electricity networks

November 2023

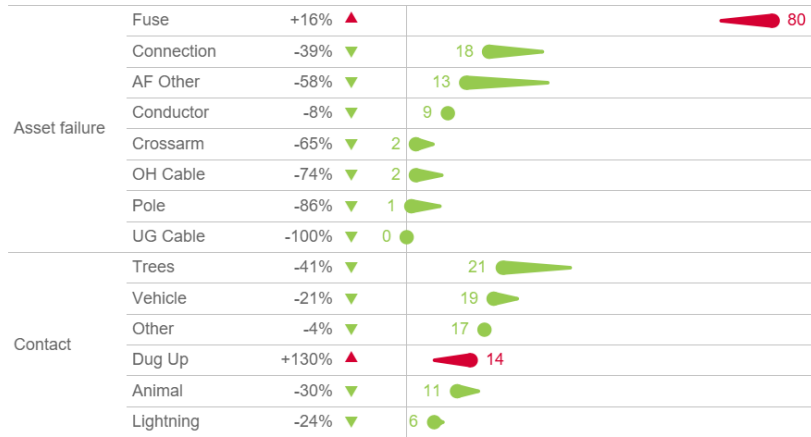
Figure 29 shows the number of serious electrical incidents reported to Energy Safe by AusNet Services during the 2022–23 period. The green arrows show the reduction from the long-term average across the 2010 to 2022 period (improvement), and the red arrows show the increase (decline). Figure 30 shows the same for those incidents that resulted in a ground or vegetation fire.

Figure 27 Incidents on the AusNet Services network

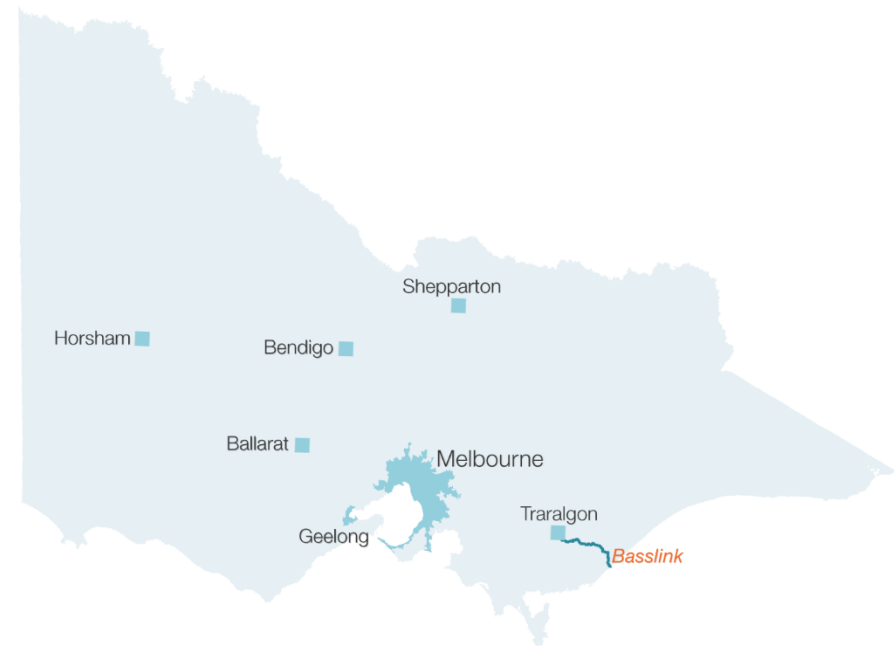
Basslink owns and operates the high-voltage direct-current interconnector between Victoria and Tasmania. In Victoria, its assets comprise the Loy Yang converter station connected to the 500kV transmission system via 3.2 km of overhead line. From the converter station, 57 km of overhead line and 6.4 km of underground cable connect to the submarine cables that cross Bass Strait to Tasmania (Figure 31). Only the onshore assets in Victoria are subject to regulation by Energy Safe.

Figure 29 Location of Basslink transmission assets (dark blue line)

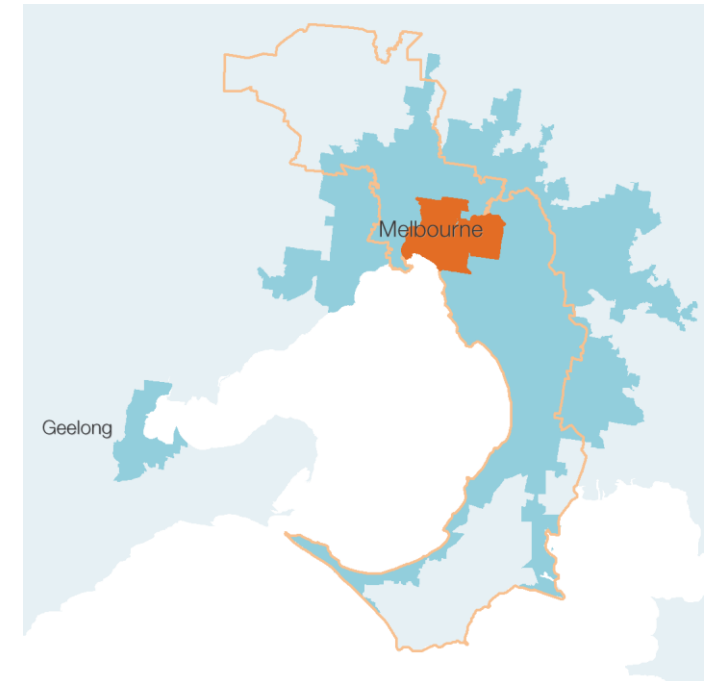
The CitiPower distribution network covers an area of approximately 157 km² and includes Melbourne's central business district and inner suburbs (Figure 32). It comprises approximately 2,530 km of overhead line, 2,710 km of underground cable, 48,200 power poles and 235,500 public lighting poles.

Figure 30 Service area for the CitiPower distribution network (orange area)

Jemena and United Energy service boundaries are shown as orange lines

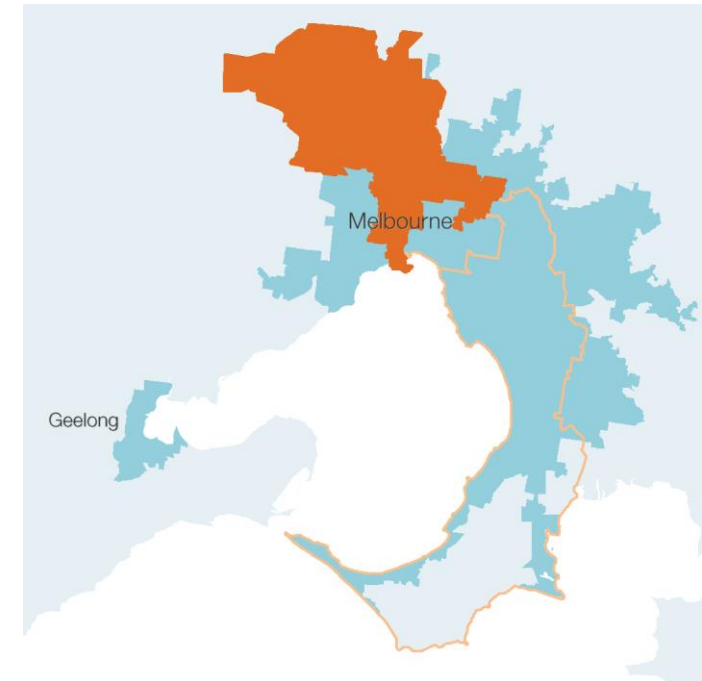
The Jemena distribution network covers an area of approximately 950 km², across Melbourne's northern and western suburbs, including Melbourne International Airport (Figure 36). It comprises approximately 4,500 km of overhead line, 2,300 km of underground cable, 94,300 power poles and 29,900 public lighting poles.

Figure 34 Service area for the Jemena distribution network (orange area)

CitiPower and United Energy service boundaries are shown as orange lines

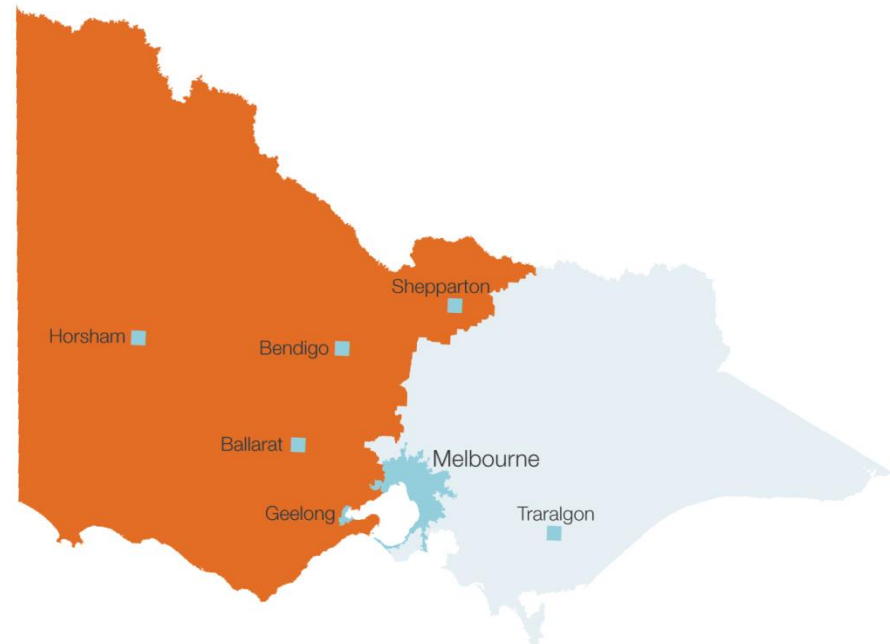
The Powercor distribution network covers an area of approximately 145,700 km², and includes Melbourne's Docklands Precinct, west from Williamstown to the South Australian border, north to the Murray and south to the coast (Figure 40). It comprises approximately 68,790 km of overhead line, 9,800 km of underground cable, 487,090 poles and 107,050 public lighting poles.

Figure 38 Service area for the Powercor distribution network (orange area)

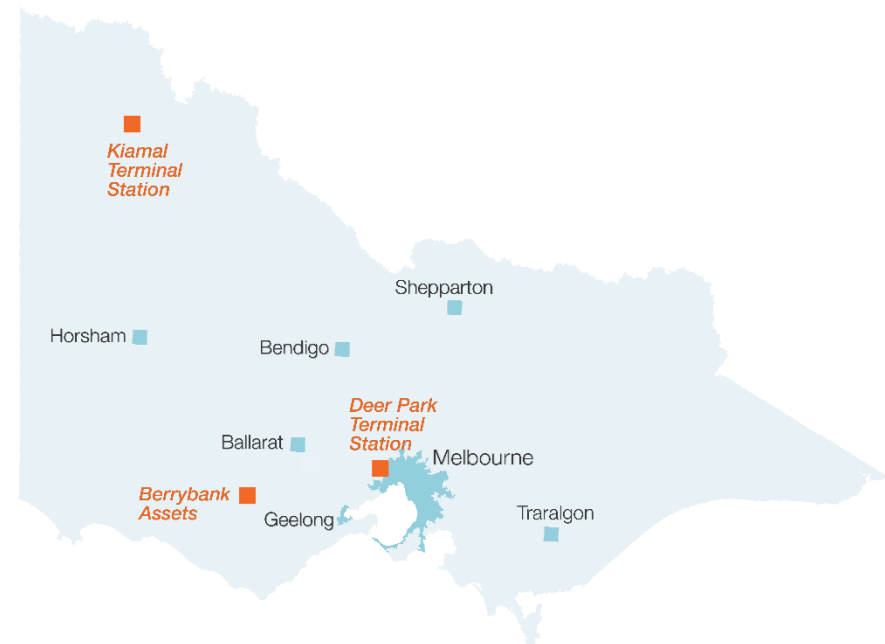
Transgrid operates and manages the high voltage electricity transmission network in New South Wales and the Australian Capital Territory. Recently, Transgrid has expanded its asset base to include assets in Victoria where it is servicing specific customer projects. These assets include the Deer Park Terminal Station, the Kiamal Terminal Station and the Berrybank Terminal Station and Zone Substation. Transgrid also operates a 7.5 km 220kV overhead transmission line from Berrybank Terminal Station to Berrybank Zone Substation (Figure 44).

Transgrid also owns and operates assets that link Victoria to the New South Wales transmission networks at the Red Cliffs Terminal Station near Mildura. In Victoria, the transmission line consists of 1.5 km of single circuit 220 kV powerline supported on four steel towers built in 1979.

Figure 42 Locations of Transgrid assets (orange squares)

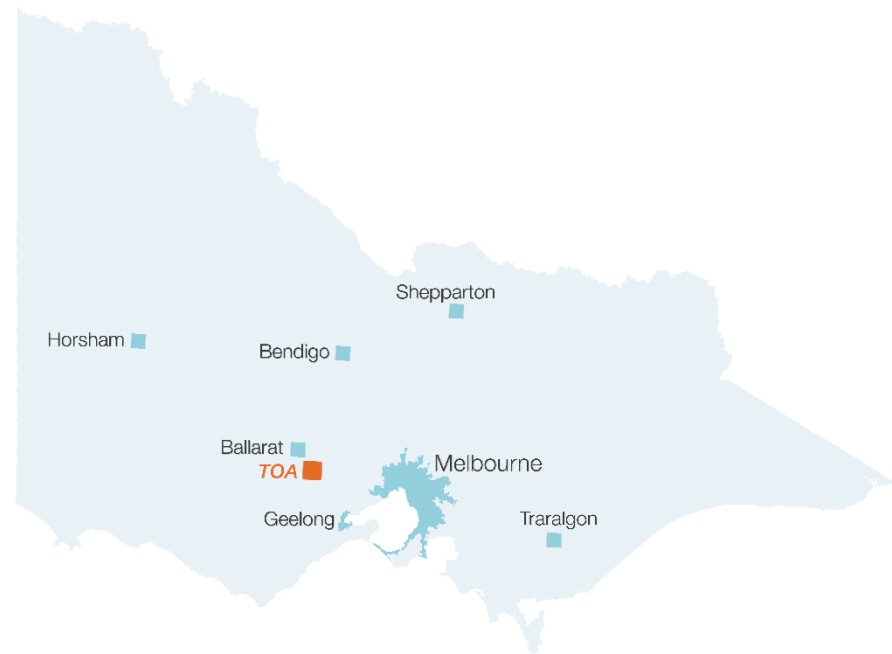
TOA owns and operates the connections from the Mt Mercer Wind Farm and from the Moorabool North and South Wind Farms to the electrical transmission network (Figure 45). The Mt Mercer transmission line is a 22km 132kV powerline and the Moorabool North and South transmission line is a 30km 132kV powerline. Both connect to the Elaine Terminal Station, which steps the voltage up from 132kV to 220kV for injection into the AusNet Services transmission network.

Figure 43 Location of TOA transmission assets (orange square)

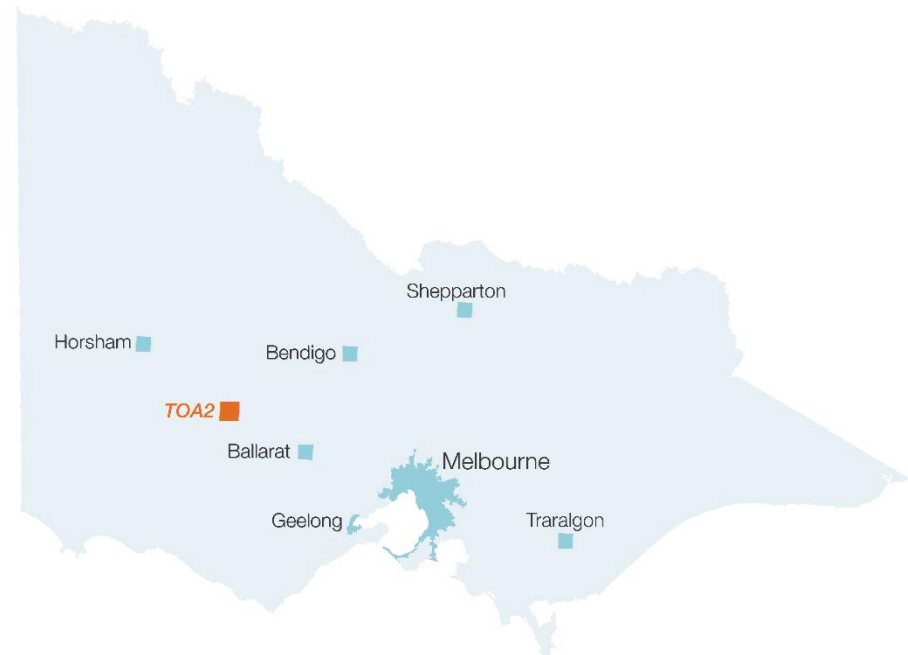
Figure 45 Location of TOA2 transmission assets (orange square)

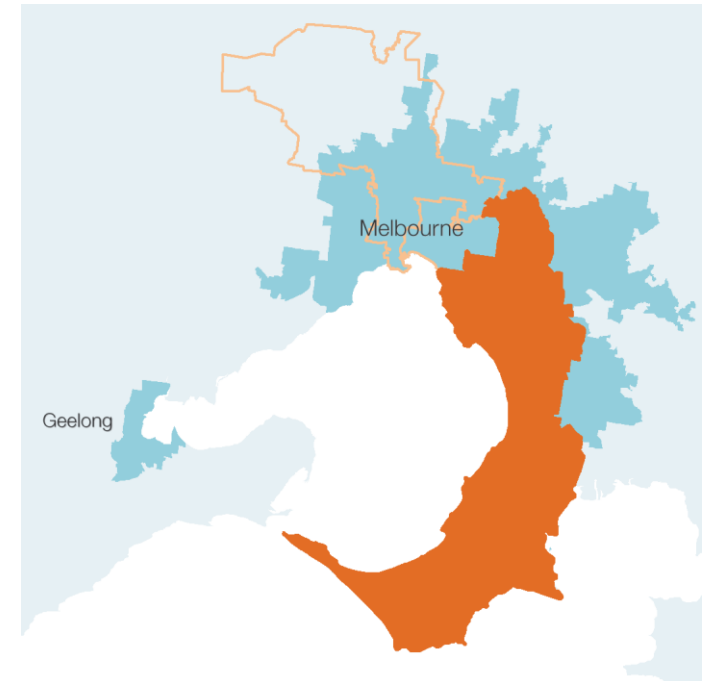
The United Energy distribution network covers an area of approximately 1,470 km² across Melbourne's eastern and south-eastern suburbs and the Mornington Peninsula (Figure 48). It comprises approximately 10,020 km of overhead line, 3,620 km of underground cable, 168,200 poles and 35,600 public lighting poles.

Figure 47 Service area for the United Energy distribution network (orange area)

Jemena and CitiPower service boundaries are shown as orange lines
